100 Lemon Peel Way Anytown, FL. 55555

Mr. John Smith 100 Lemon Peel Way Page 1 of 48

## **Recommend Maintenance Summary**

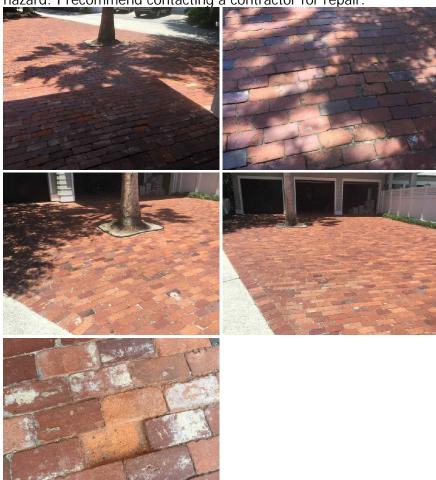
1. Recommend Maintenance Driveway: Observed - The driveway has settled and heaved. This is a possible trip

hazard. I recommend contacting a contractor for repair.

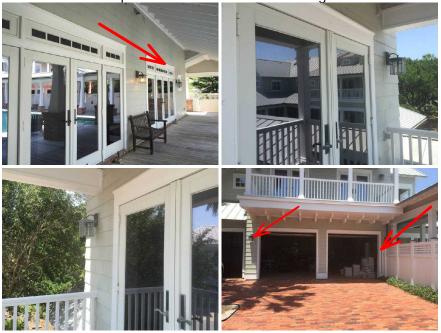
Exterior Lighting: Observed - The light fixture was not working at the time of inspection. This may be a burned out bulb. Recommend replacing the bulb and if this does not cure the problem recommend contacting a licensed electrician for repair.

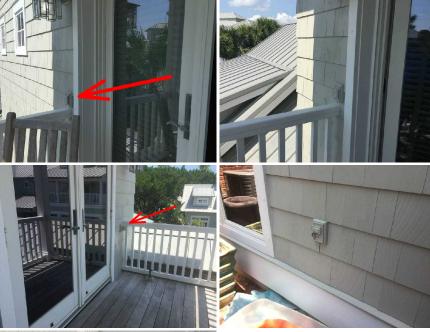
Exterior Electric Outlets: The GFI outlet was not working at the time of inspection. The cover was missing. The moisture cover is missing. I recommend contacting a licensed electrician for repair.

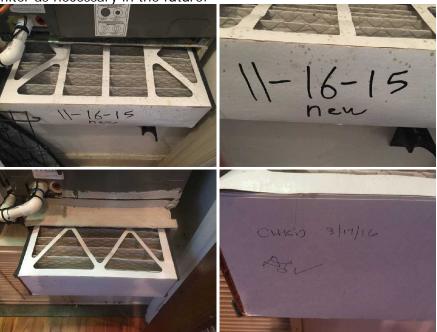
Filters: Observed - The filter is dirty and should be changed. I recommend contacting a licensed handyman to install a new filter. I recommend replacing the

filter as necessary in the future.

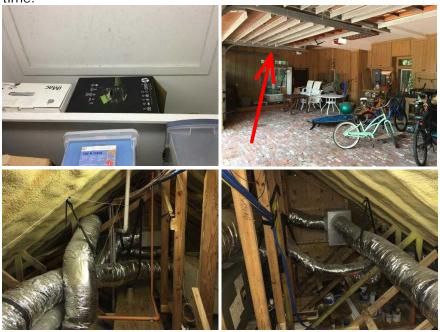
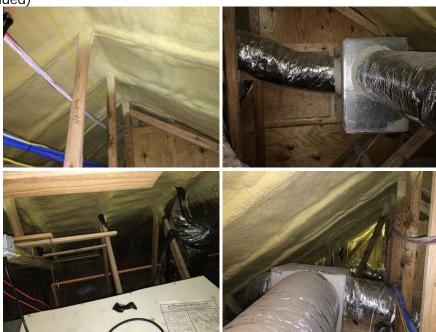
Unable to Inspect: 65% - There is limited access due to the framing and areas that are concealed. All visible areas were inspected. Note: There are two points of access that were not accessible do to the homeowners belongs. No action required this time.

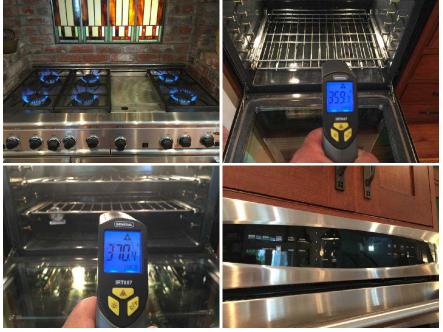
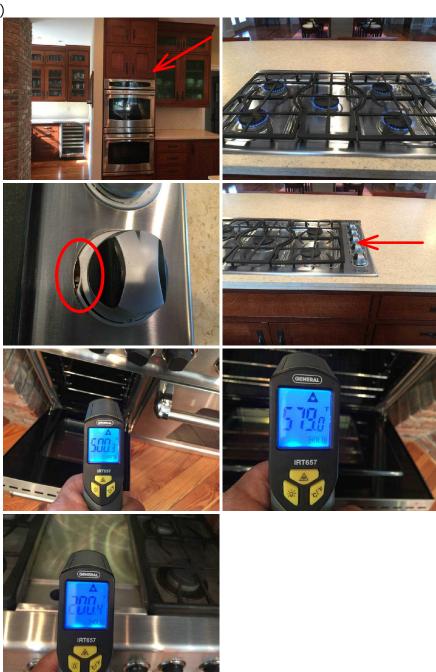
Stove & Oven: DCS - The control panel is not working. There is a missing lens cap on the control knob. I recommend contacting an appliance repair company for repair.

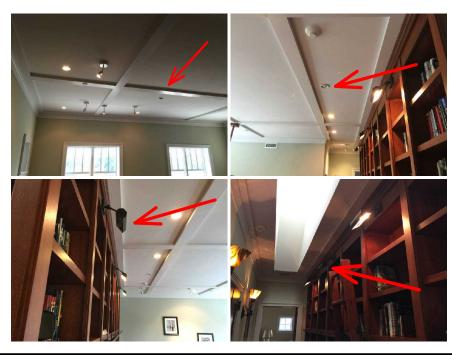
37. Repair/Replace Lighting: Observed - The light is out.
